THE OBSERVER

★ **Deck Collapse?** ★
Not on my watch!

Deck Fastener Corrosion

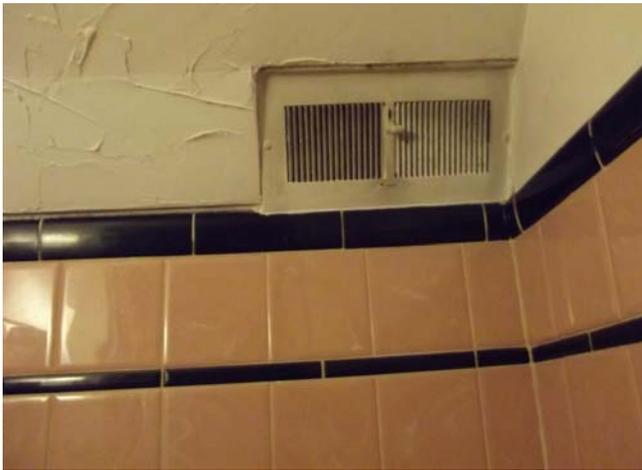
What's wrong here?

This vent was tied directly to the outside. One very cold bathroom during the winter.

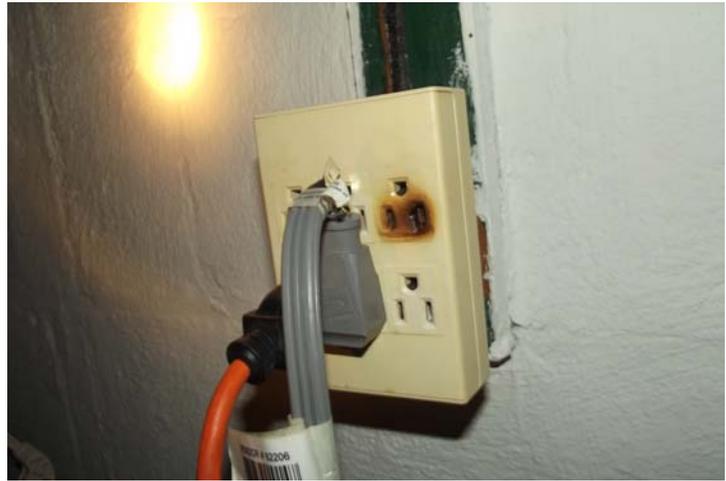
Once it has scorched, always recommend having the receptacle replaced. We do not know what condition the interior is in.

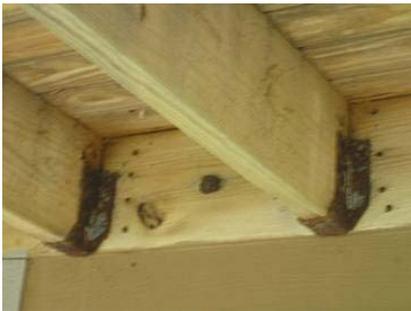
This past Saturday, I opened my newspaper and read the following: "The metal joist hangers that are holding together my deck

are rusting a lot. Should I be worried?" The answer given chilled me to the bone. The reply started with the word, "No." and went on to refer to the hangers being made from galvanized steel, therefore were rust-resistant. It also went into an explanation, stating that it may be "just a patina" which may keep the metal from rusting further. I should add that within 5 minutes of reading this article, I received a text from a fellow home inspector, alerting me of a local deck collapse that he had just learned about. Pressure treated wood used on decks that were constructed prior to 2004 was often treated with Chromated Copper Arsenate (CCA). One of the benefits from this treatment was the copper and arsenate would

These two replacement treatments, ACQ and CA do, pretty much, work as well in protecting the wood products from rot, though from the onset, differing levels of metal fastener deterioration began to develop. This was due to the lack of corrosive-inhibiting chromium and arsenic. The other issue here was the copper content in the newer treatments was much higher, which increased the galvanic reaction when this leached out of the lumber and came in contact with the fasteners. Add that to the ammonia which is also found in some of the CA and ACQ treatment, and we end up with a recipe for corrosive disaster. As the zinc coating gets eaten away from the underlying steel fasteners, it's just a matter of time before the deck is held aloft by those few toenails that were inserted temporarily into the joists until the hangers could be put in place. Not much of a comfort when you add a family on to the surface, is it?

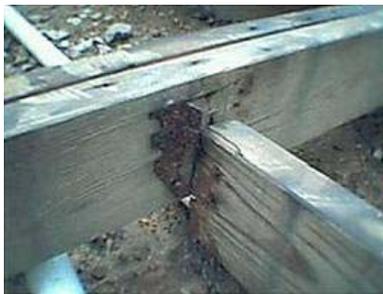
assist in controlling corrosion to the fasteners. This chemical treatment was changed in 2004 due to health concerns over the use of arsenic (US) and Chromium (Europe). The companies manufacturing the chemicals for these products, in an effort to be consistent worldwide, developed replacement treatments which are Copper Azole (CA) and Alkaline Copper Quaternary (ACQ). (Sodium Borate-treated lumber is also in the mix, though we won't discuss that here. That was found, in testing, to be more corro-

sion-resistant that even CCA. Also, we won't spend time discussing the use of roofing nails, which are ever-present, to attach the fasteners, which is wrong, wrong, wrong. I'll let you research that yourself.)

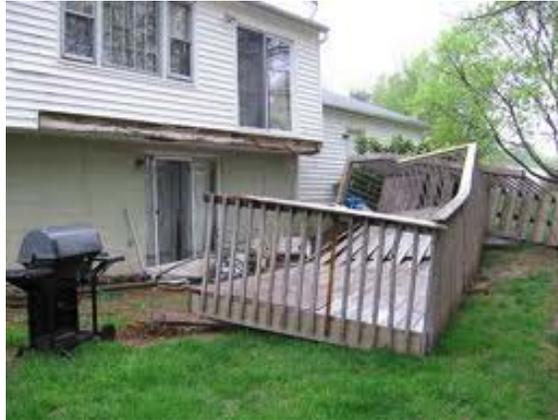
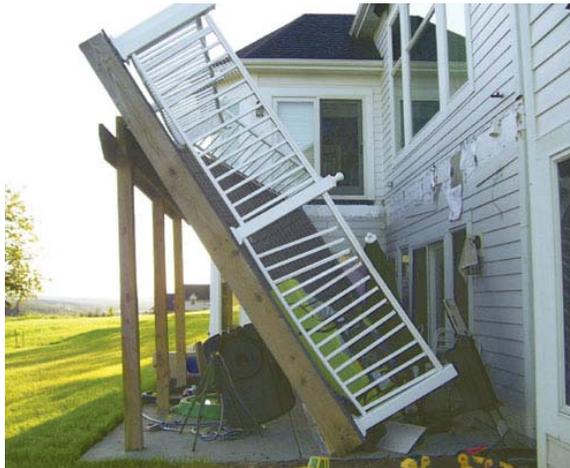
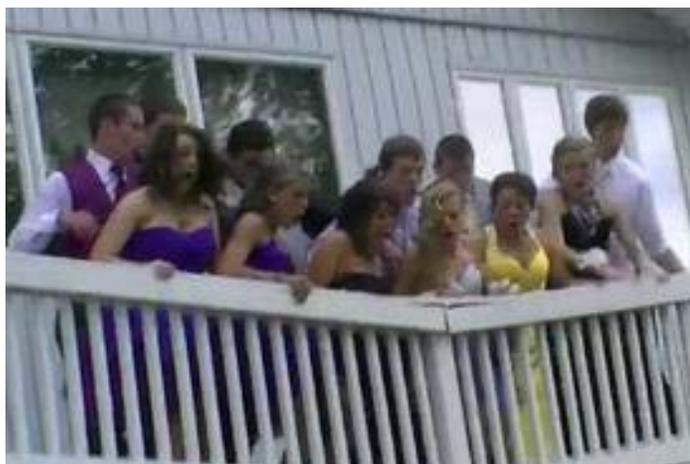
Look very closely at these fasteners, as they can very easily be death traps waiting to happen.

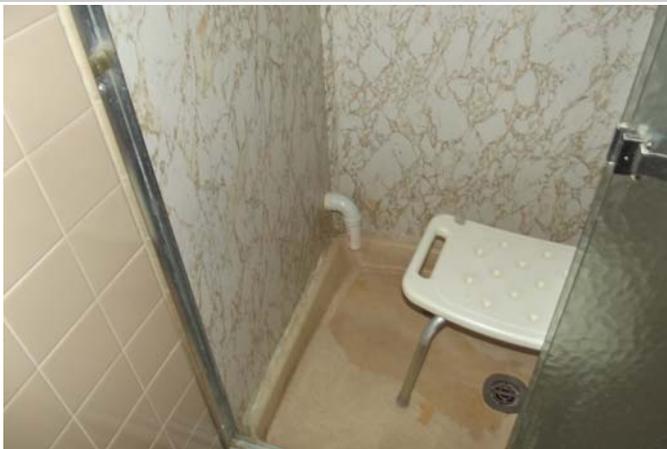
Below are two photos, provided by Tom Sherman. The photo to the left shows a condensate discharge from a high efficiency furnace located in the adjacent room. Caustic condensate will surely make for a "hot" shower on one's feet.

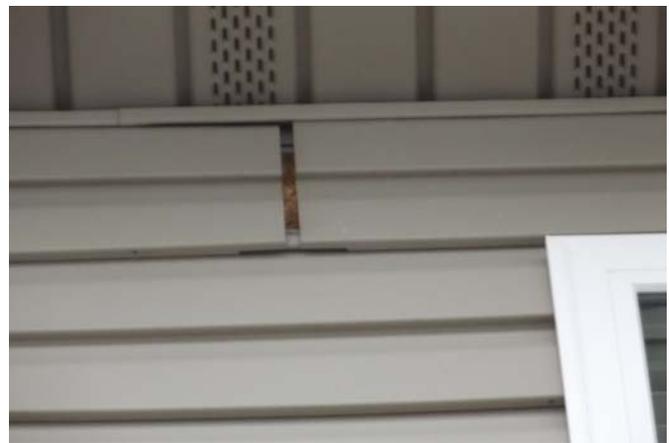
The photo to the right displays the lack of a building wrap behind vinyl siding. Just because it met "code" at time of construction, should not deter us from pointing out the obvious to our client. I would love to see this OSB in 10 years

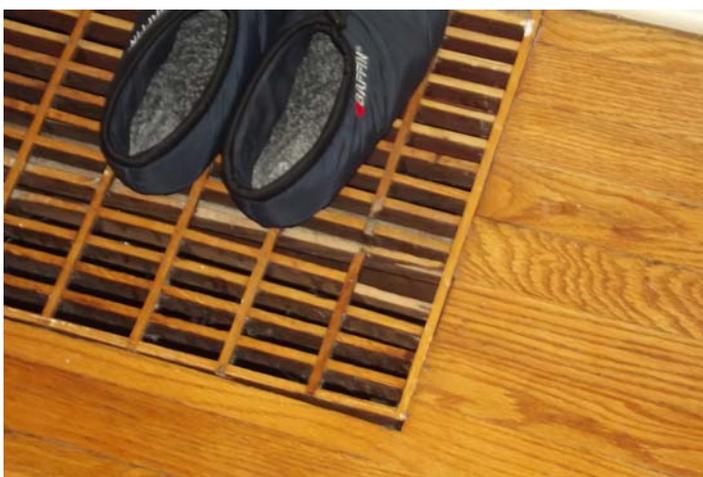
Yes, they are all broken. Yes, they can easily become trap doors. Point them out and recommend replacement.
